Cultural Resources Survey Report

Blue Lake Hydroelectric Project (FERC No. 2230) Expansion

Sitka, Alaska

February, 2009

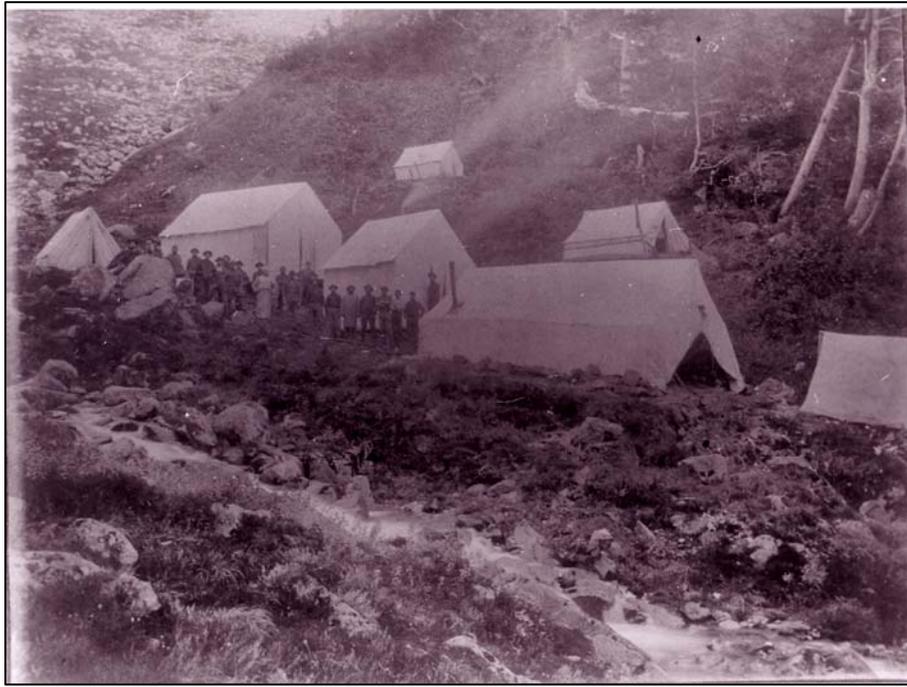
Figure 5. Pande Basin mine site, ca. 1898. Photo copied from DeArmond file. This expired placer mine is located outside the APE at approximately 457m (1371 ft) above sea level, UTM coordinates: Zone 8, Northing 6327843, Easting 495455; Quadrangle Sitka A-4: T 055S, R 065E, Sec. 1 of the Copper River Meridian.

“Construction of the road started in June 1898, with 20 men. By the end of July the force had increased to 85 men and the job was being pushed rapidly, and expensively. So costly was the road from tidewater to Blue Lake that the plan to extend it from the lake to Pande Basin was abandoned and a pack trail [SIT-00733] was built instead for that portion of the route. A camp with bunkhouses, cookhouse and mess room was constructed on a ridge above the place where the drainage tunnel was to be started” (July 23, 1898-ALASKAN-newspaper article summary, DeArmond-Sitka, Alaska) (Figure 5).

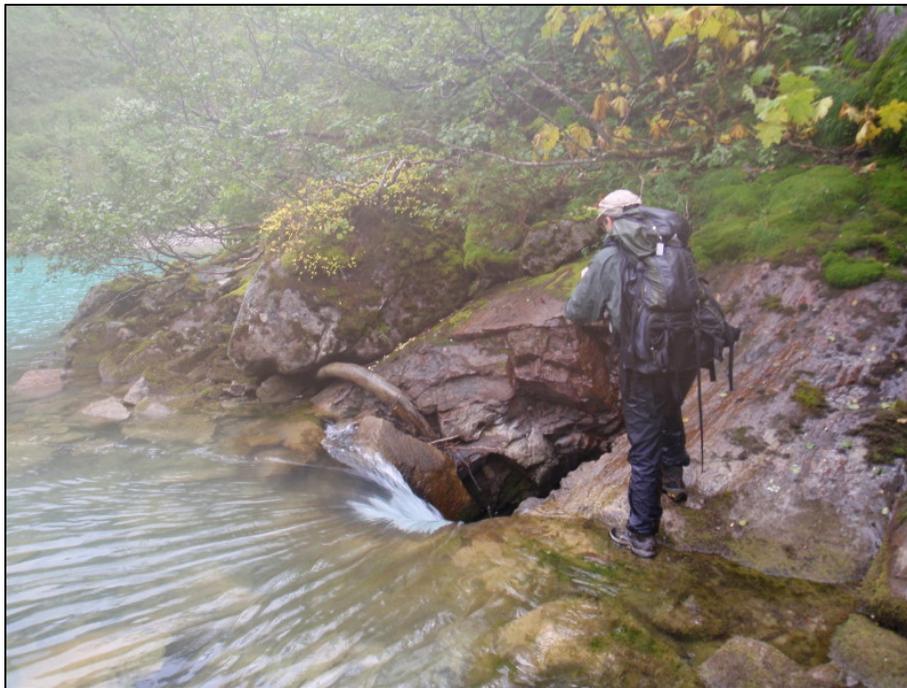
Figure 6. Pande Basin: View of the 1898, 300ft-long tunnel that lowered Glacier Lake 60ft to access placer gold. Photo courtesy of Dean Orbison.

A 5 x 7 x 300ft-long drainage tunnel was constructed to drain down Glacier Lake by 60ft to expose the gold-bearing gravel deposits (Figure 6). The tunnel was completed on December 31, 1898. By 1899 concerns were raised amongst investors about the viability of the Pande Basin mine, and by 1905 they realized the claim's ability to produce the amount of gold as advertised was a hoax; the mine was salted. A visit to the mine site by Bittenbender and others (1999) made note that there was no evidence of gold bearing gravels, nor evidence of actual mining at the site.

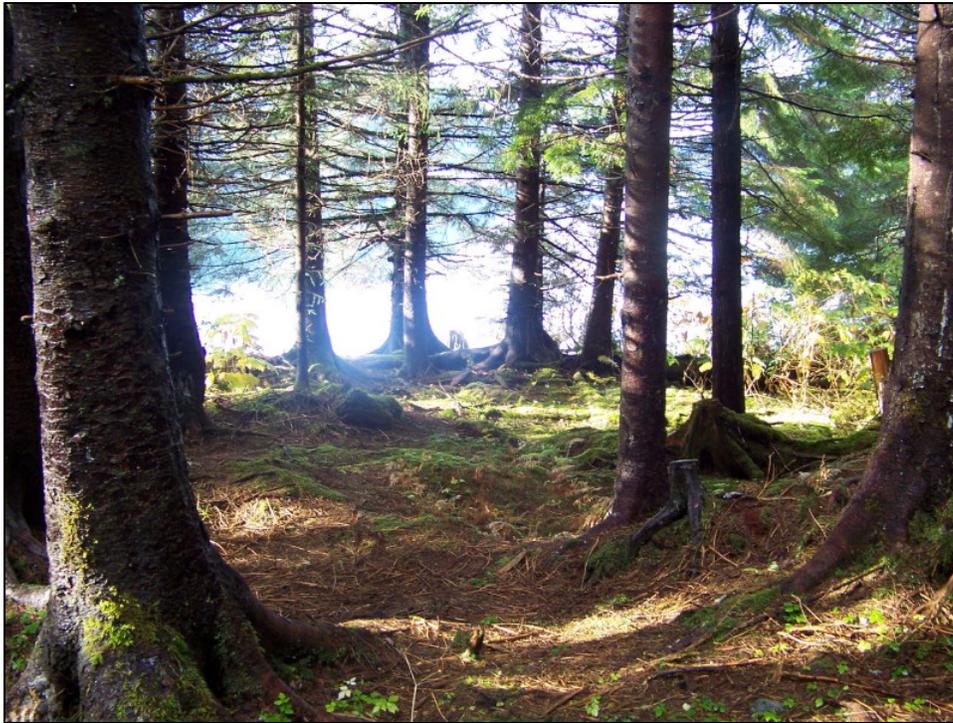
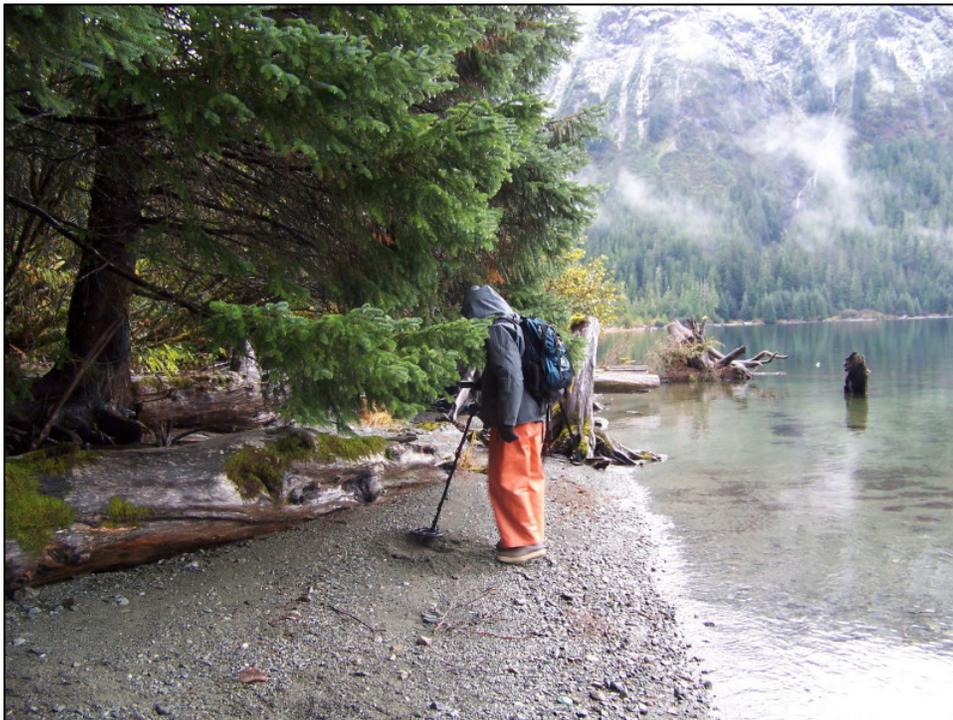
Figure 8. A) View of Boy Scout campground terrain. B) Metal detector survey of the Blue Lake shoreline near the Boy Scout campground.

A 10 x 20m campsite reportedly used by the Sitka Boy Scouts was located along the shoreline in the northeast corner of the lake (Figure 7 MAP). Other than burned aluminum foil incorporated into the beach gravel and in the small fire hearth, the area was clean of trash. The metal detector disclosed modern coins and other small, camping-related items not considered of historical significance (Figure 8. A and B). The campsite is within the APE.

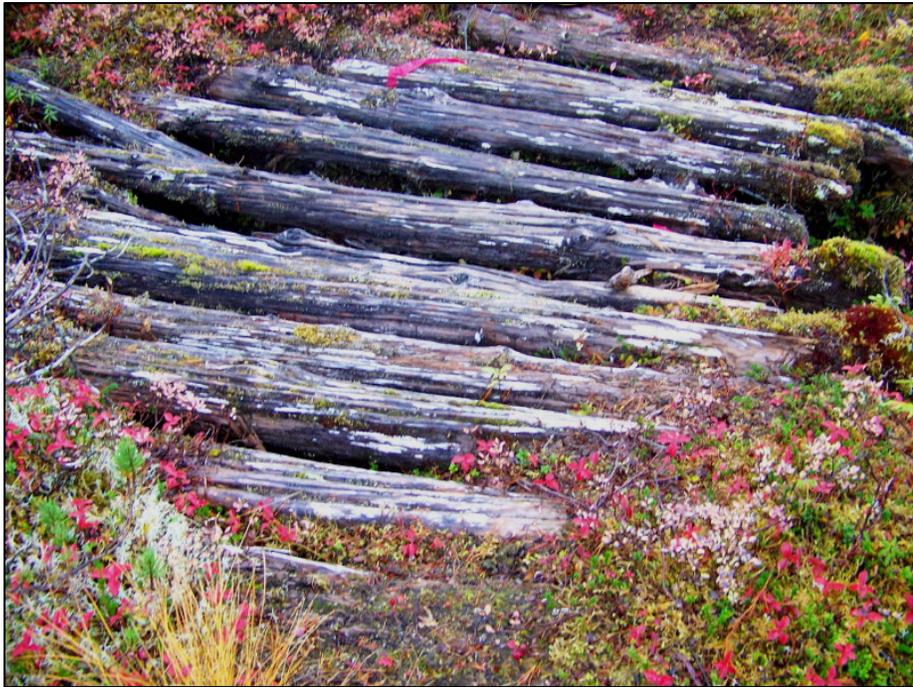
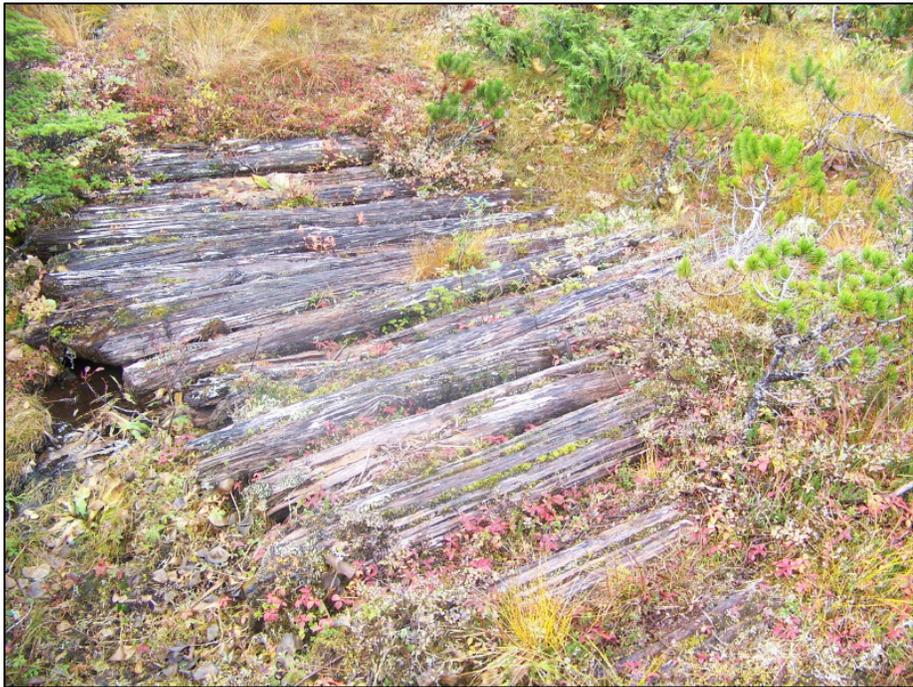
Figure 10. A) View of Segment 2 in the upland muskeg area. This segment is typical of the other corduroy found in the muskeg. B) View of Segment 5.

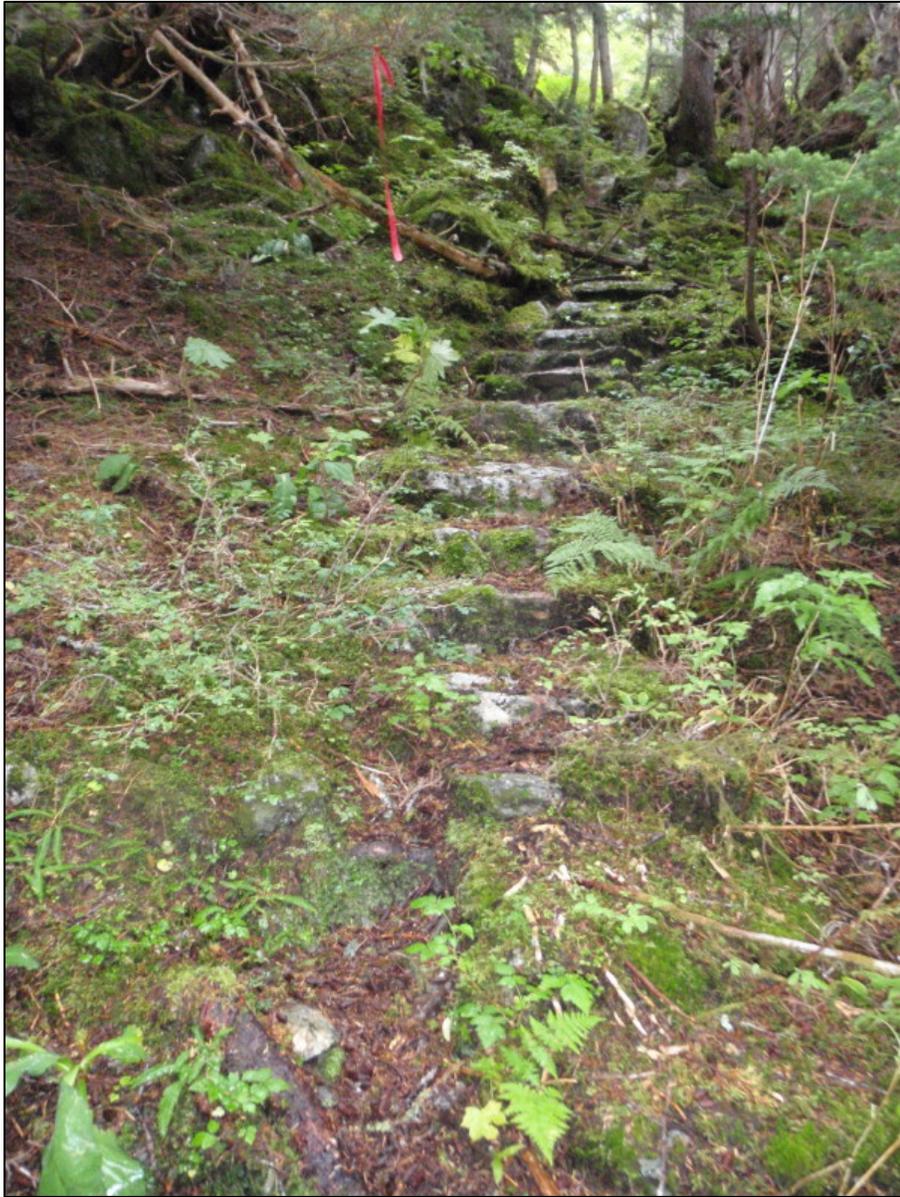
Figure 12. View of a short segment of stone steps near the beginning of the Pande Basin trail. The trail is above the proposed inundation elevation.

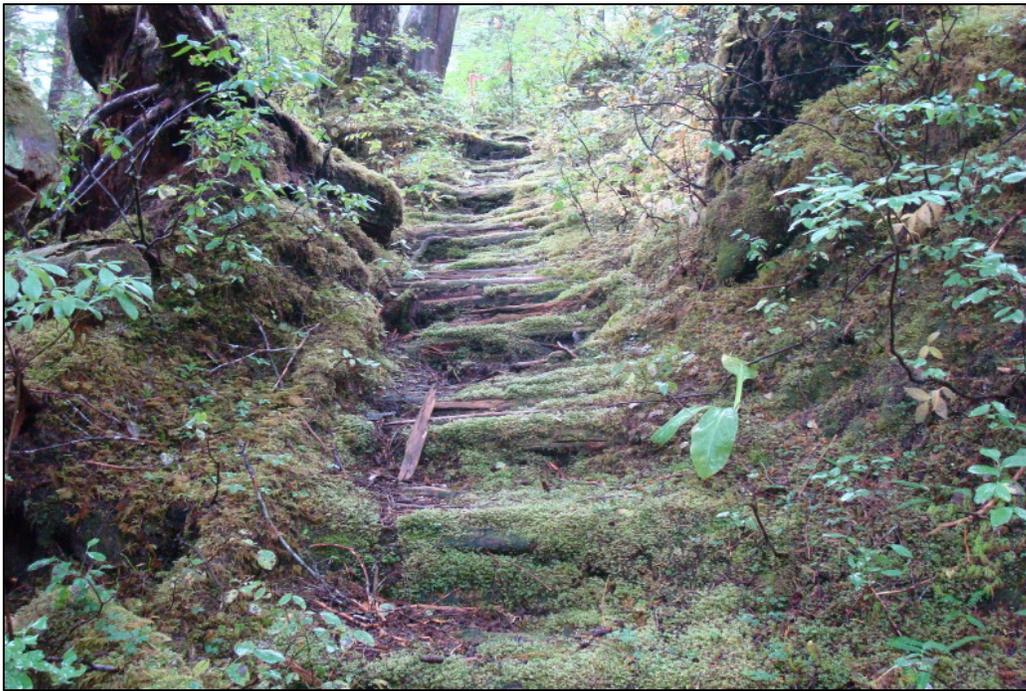
Figure 13. View of log steps on Segment 9. Photo was taken from the collapsed bridge at the end of Segment 9.

Road segments in the APE include the east end of Segment 9, and Segments 10, and 11. Segment 9 is primarily steps built with logs on a slope that descends from upland muskeg into a ravine near the floodplain (Figure 13). The part of Segment 9 potentially inundated is the collapsed remains of an 8m long log bridge built to span the ravine (Figure 14). Segment 10 is a decomposed, 4m long x 1.5m wide log bridge used to span a shallow intermittent stream. All that remains of this segment are two beam timbers and a few tread logs. Built along the Blue Lake Creek shoreline is Segment 11, which is basically a well worn game trail with short segments of corduroy (Figure 15. A and B). Segment 11 is eroding into Blue Lake Creek.

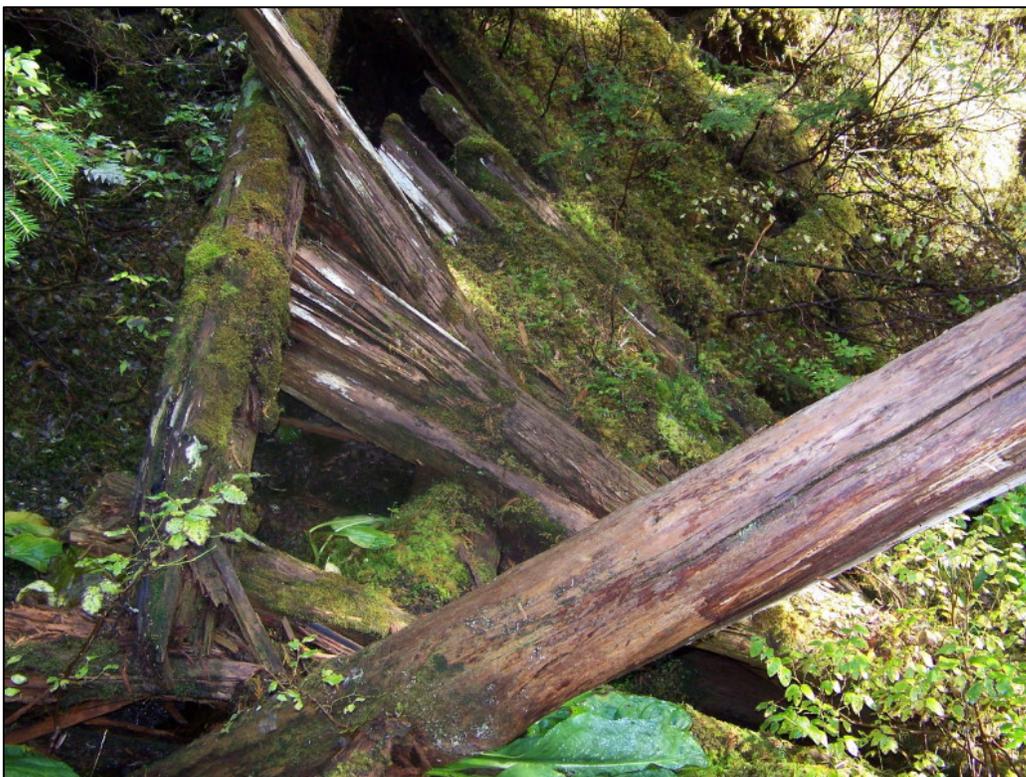
Figure 14. View of the collapsed remains of the bridge at the end of Segment 9.

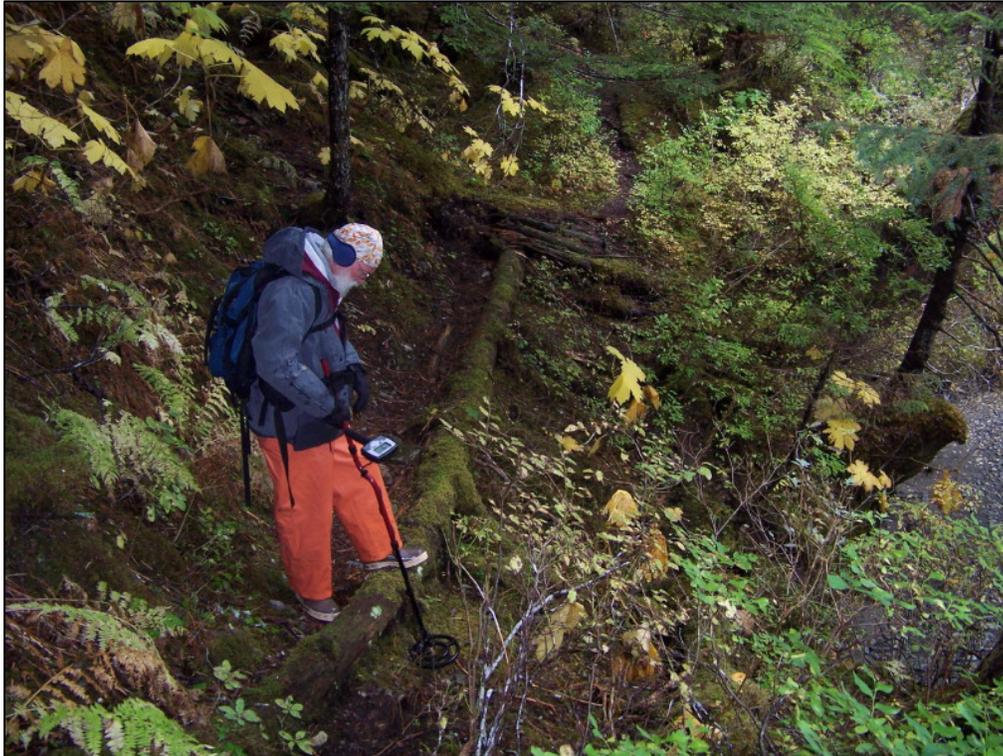
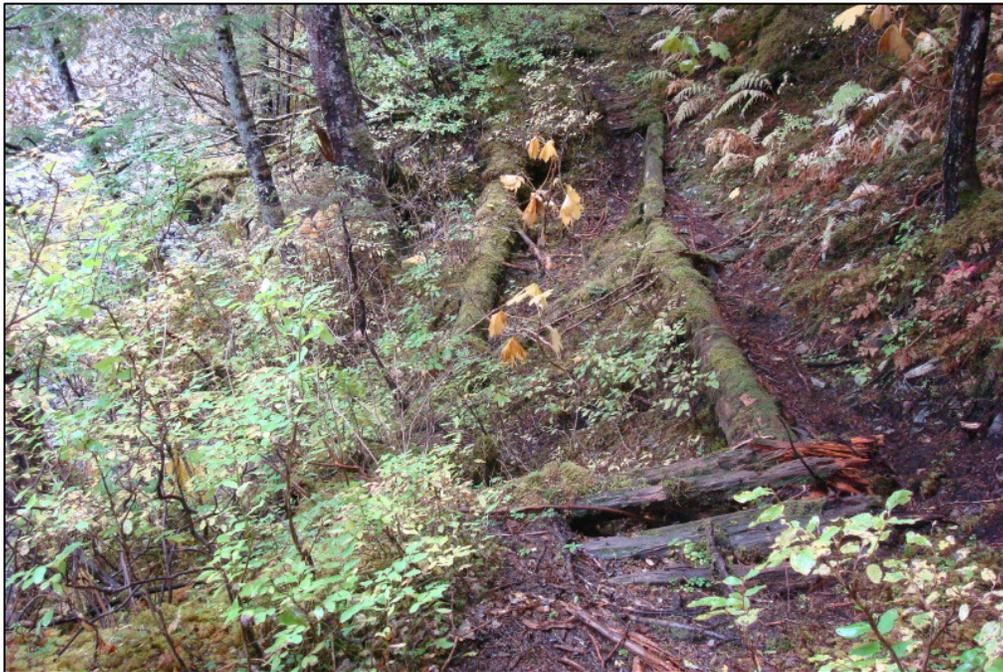
Figure 15. A) View of a metal detector survey along the remains of Segment 11 next to Blue Lake Creek (right of photo). B) View of Segment 11; Blue Lake Creek is left of photo.

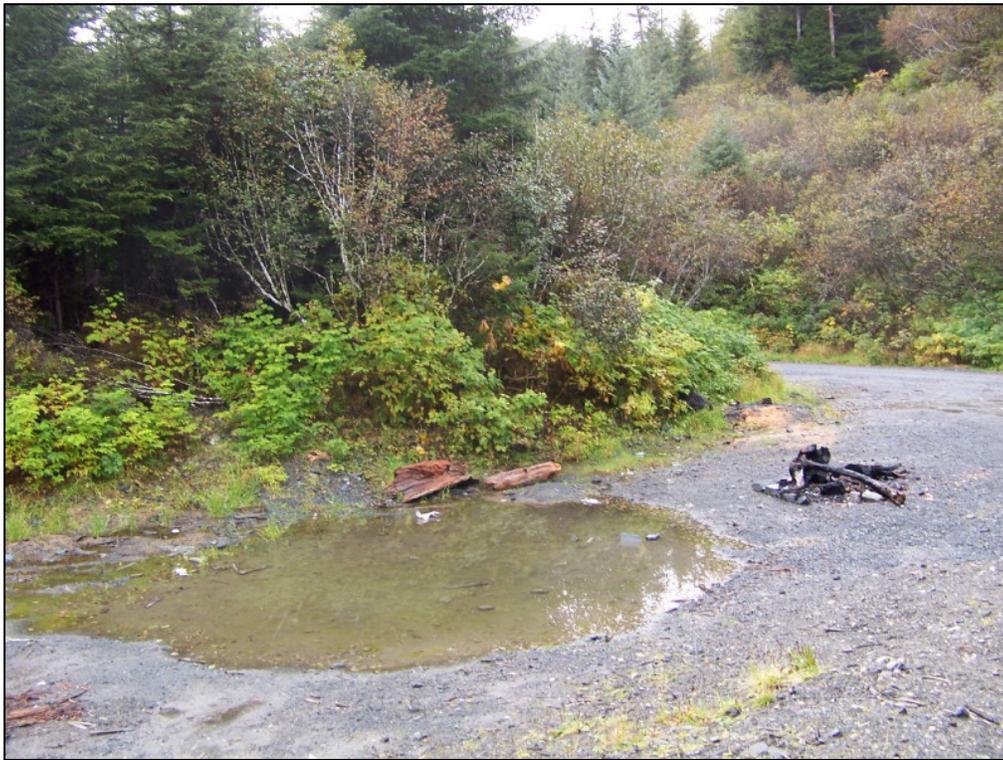
Figure 16. View of the survey conditions near the dam site.

In this area surveyors found modern trash, fragments from a rusted cast iron stove just inside the tree line near the parking area (Figure 16), and a partially buried 20ft joint of 3 inch metal tubing. This area in general has sustained various types of impacts in the last 40 years.

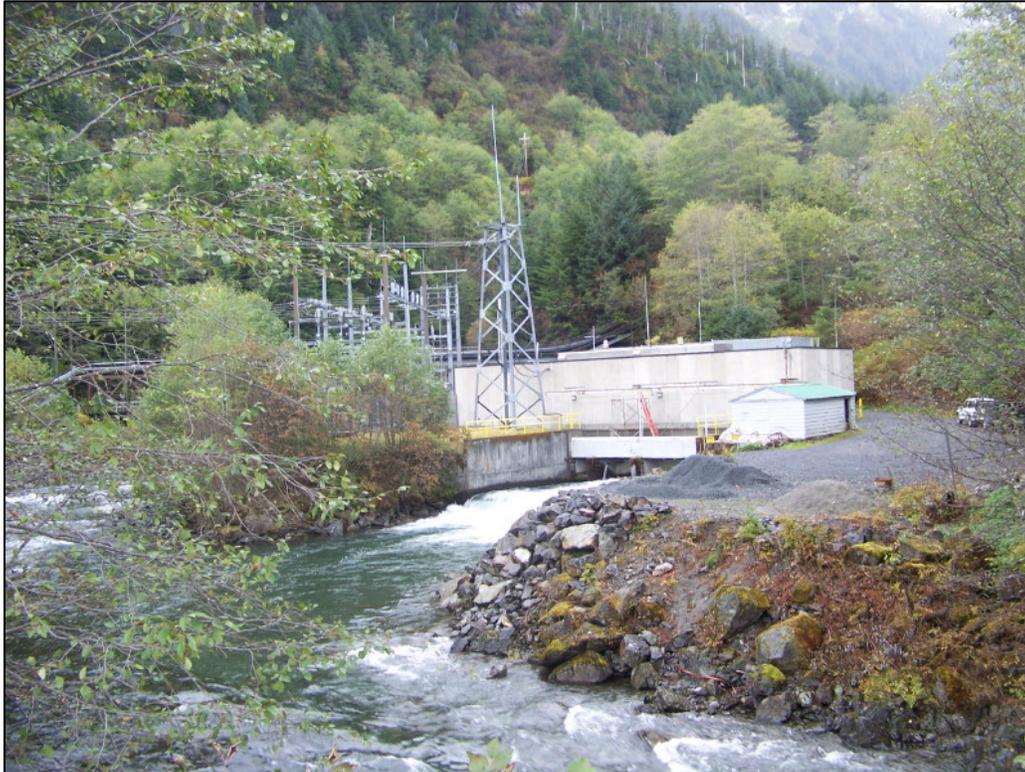
Figure 17. View of the powerhouse area and Saw Mill Creek in the Lower APE.

No cultural resources were found in this area. After two intensive surveys in 2004 and 2008, the potential for cultural remains in the areas proposed for the new turbine and infrastructure, tunnels and surge chamber is extremely low. Extensive cut and fill modifications are apparent throughout the area (Figure 17). Any potential archaeological evidence of ancestral use of the Sawmill Creek littoral zone is beneath 123 acres of fill material placed during the construction of the APC mill site in 1959. Mill construction also diverted to the south of its original position the confluence of Sawmill Creek and Silver Bay (Figure 18).

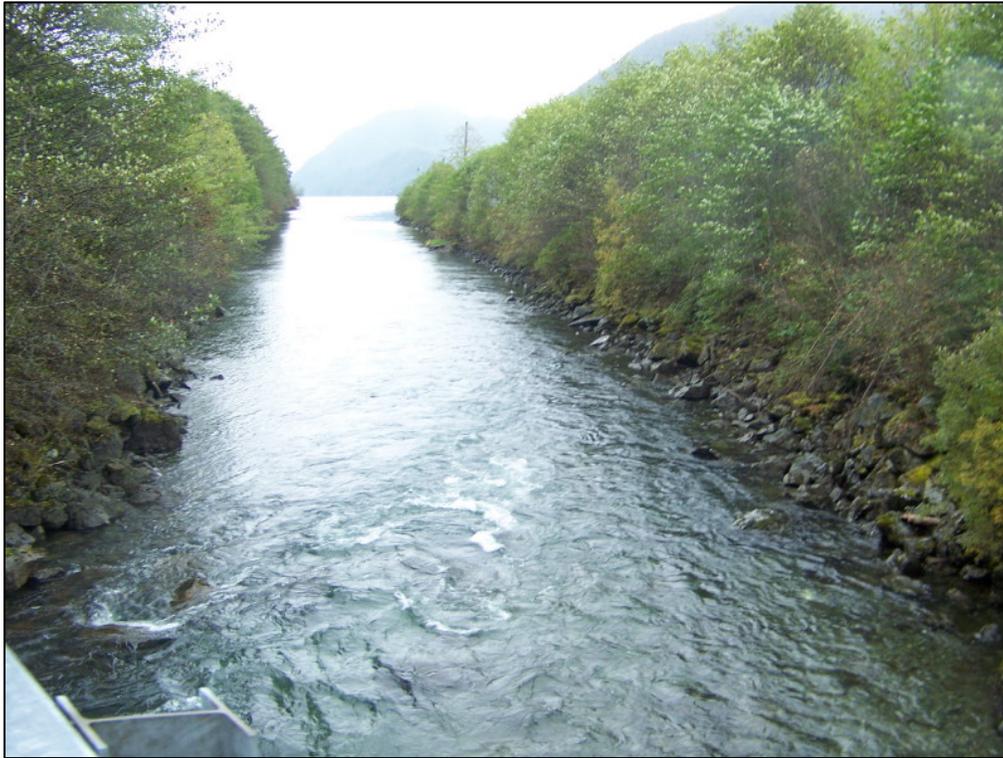
Figure 18. View of Sawmill Creek below the powerhouse as it nears Silver Bay.
